Preparing for the Fall Storm Season: Flood & Erosion Observations

**LEO Network Webinar
September 2021**

Alaska Division of Geological & Geophysical Surveys
Coastal Hazards Program

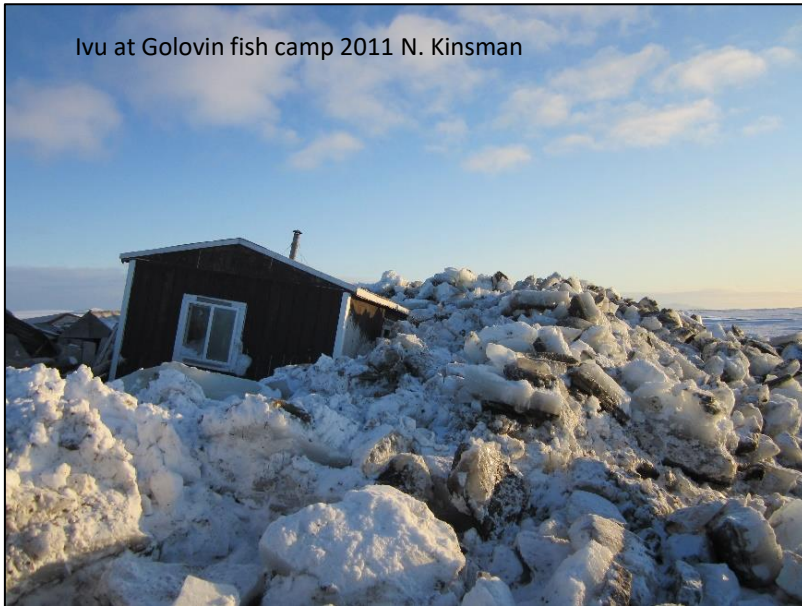
Storm Surges

Sea ice mitigates wave development in off/nearshore.

Sea ice reduces friction on water level bulge travelling toward coast.

Nearshore transported onto beach as slush berm or Ivu.

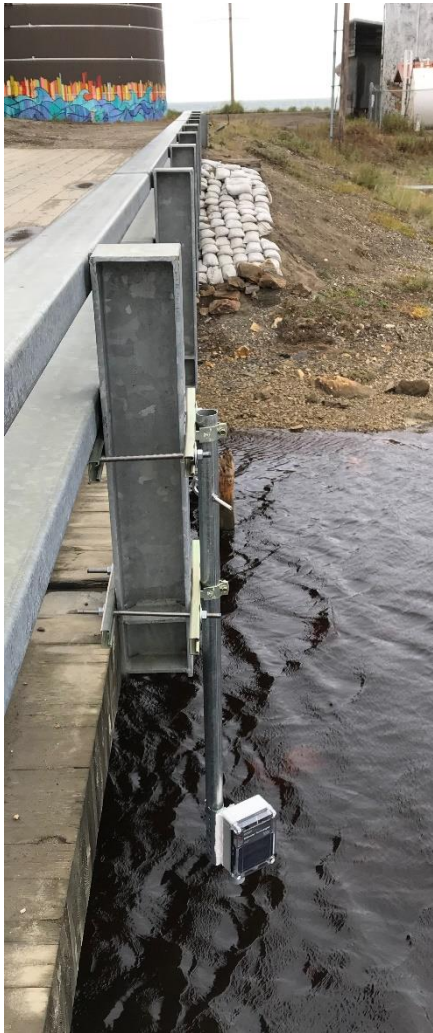
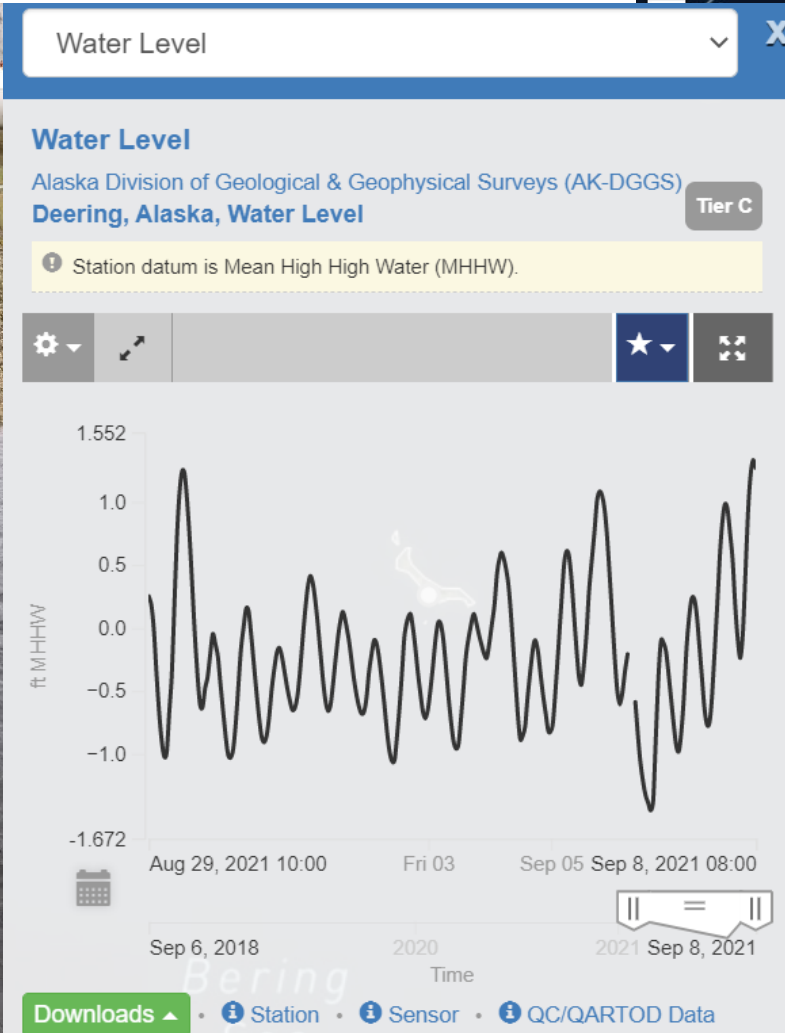
Storm Observations

Water level sensors

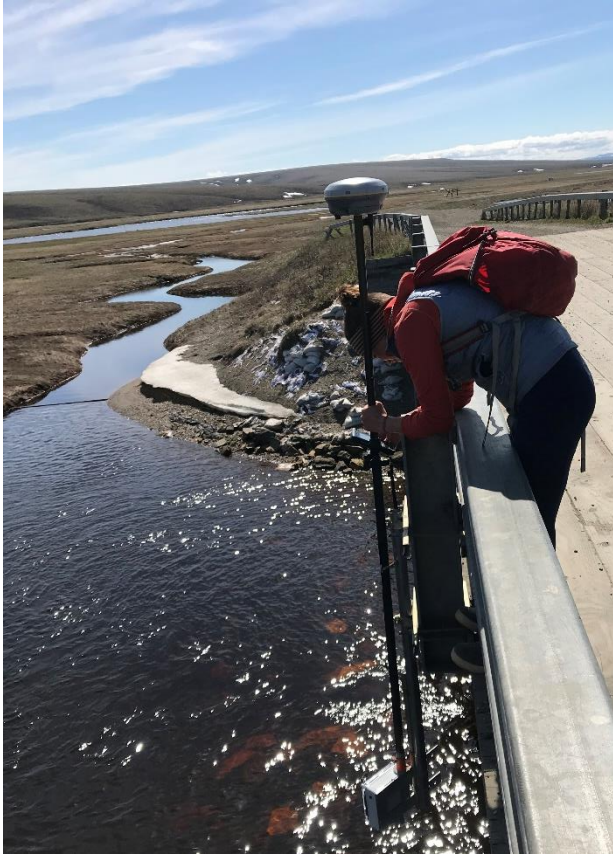
Deering

Water level sensors

In Need of Repair

- Kotzebue
- Tununak

Operational in Western and Northern AK

- Naknek
- Bethel
- Nome
- Red Dog
- Unalakleet
- St. Michael
- St. Paul

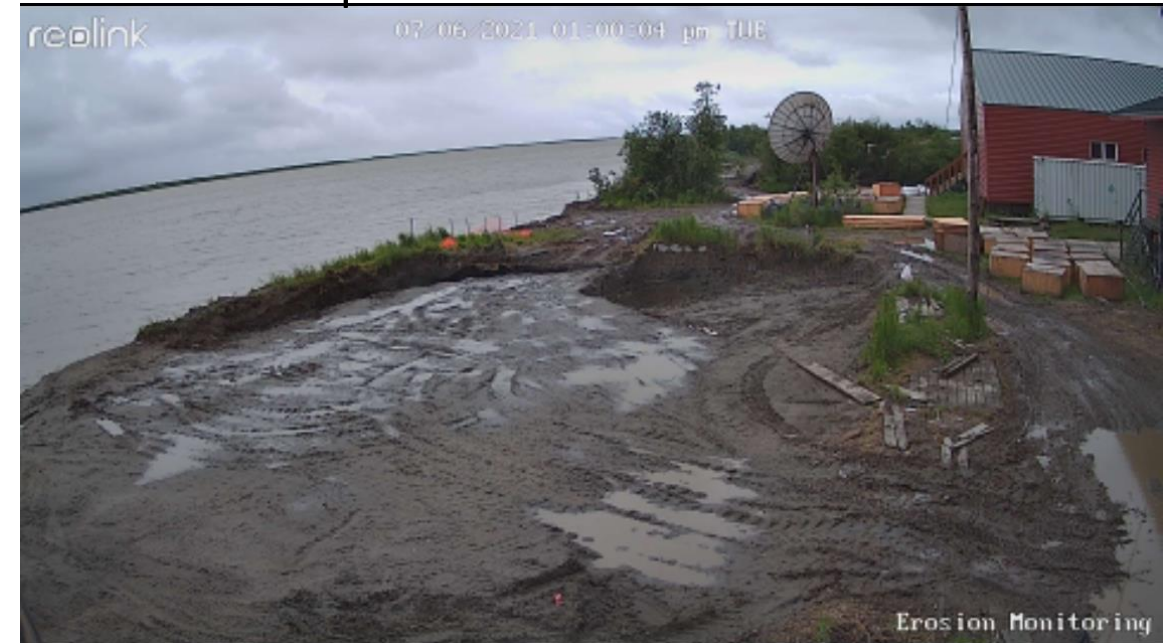
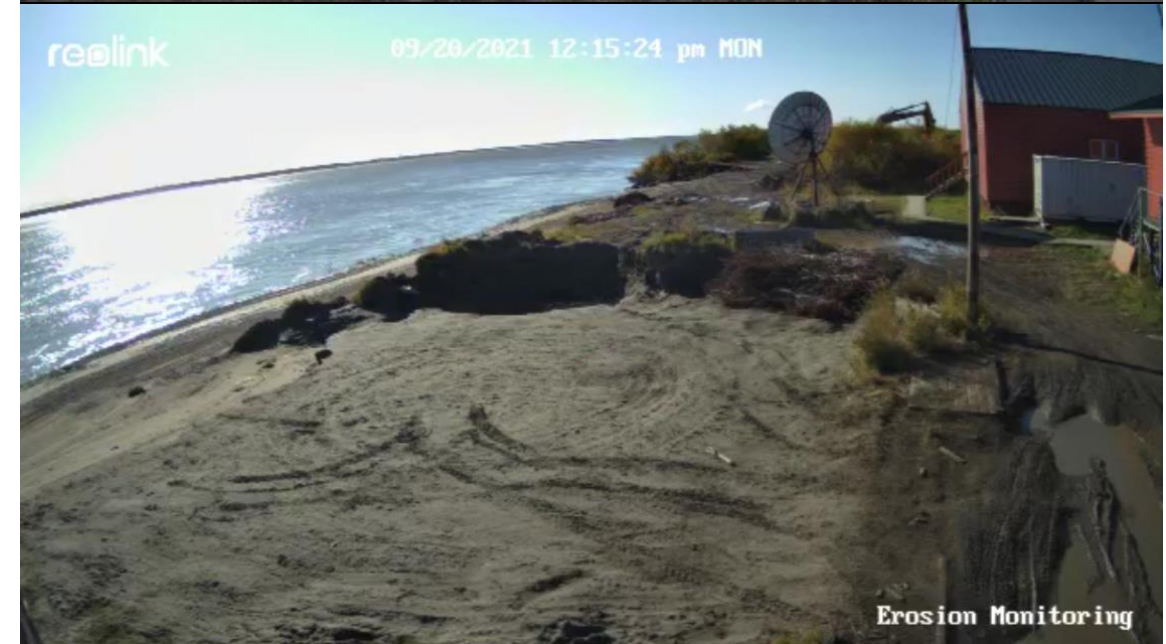
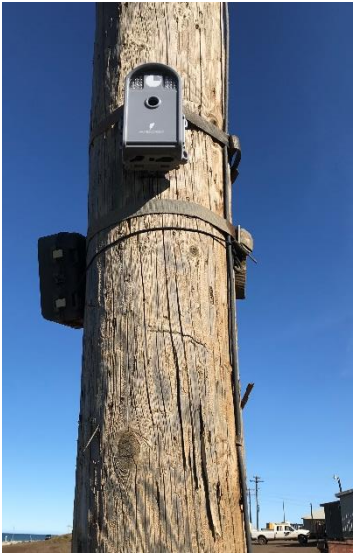
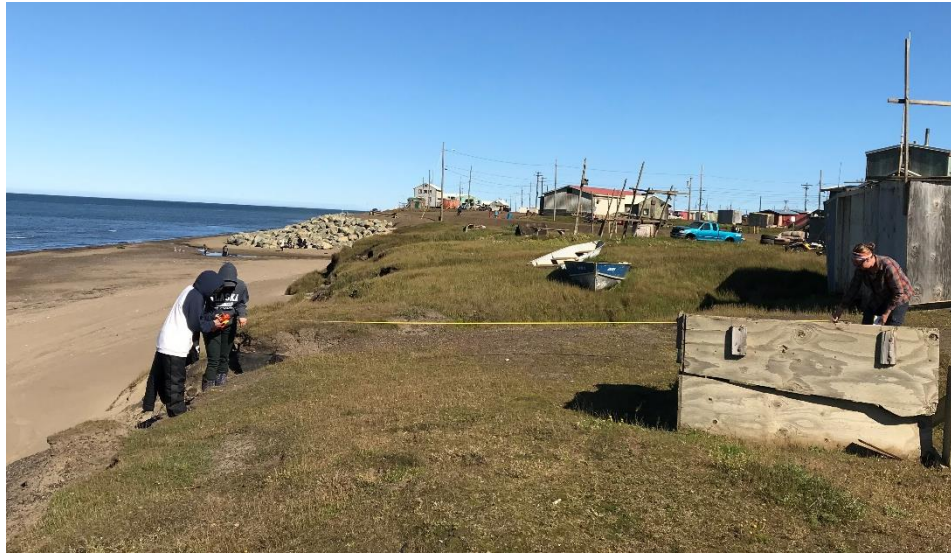
Community Monitoring of Erosion
Stakes for Stakeholders

Webcam at Napakiak
